**DEPARTMENT OF TRANSPORTATION**

Contract #: 04-0120F4Cty: SF/ALA Rte: 80 PM: 13.2/13.9File #: 69.28**WELDING INSPECTION REPORT****Resident Engineer:** Siegenthaler, Peter**Address:** 333 Burma Road**City:** Oakland, CA 94607**Report No:** WIR-018362**Date Inspected:** 22-Nov-2010**Project Name:** SAS Superstructure**OSM Arrival Time:** 700**Prime Contractor:** American Bridge/Fluor Enterprises, a JV**OSM Departure Time:** 1900**Contractor:** Zhenhua Port Machinery Company, Ltd (ZPMC), Changxing Island **Location:** Shanghai, China**CWI Name:** Xu Le Feng, Geng Wei**CWI Present:** Yes No**Inspected CWI report:** Yes No N/A**Rod Oven in Use:** Yes No N/A**Electrode to specification:** Yes No N/A**Weld Procedures Followed:** Yes No N/A**Qualified Welders:** Yes No N/A**Verified Joint Fit-up:** Yes No N/A**Approved Drawings:** Yes No N/A**Approved WPS:** Yes No N/A**Delayed / Cancelled:** Yes No N/A**Bridge No:** 34-0006**Component:** OBG/TOWER**Summary of Items Observed:**

## WELDING INSPECTION REPORT

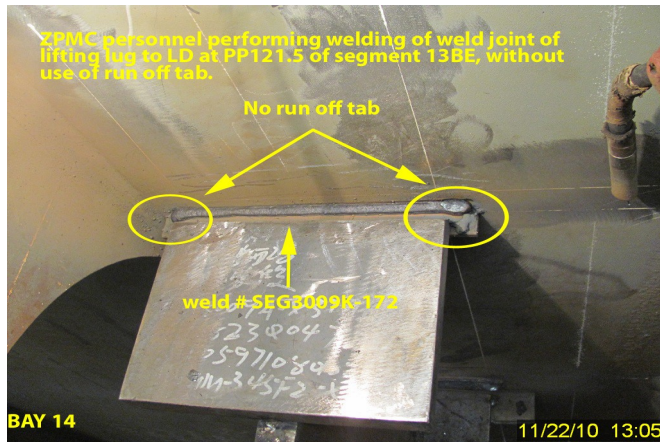
During random in process inspection this QA inspector observed that ZPMC personnel was performing welding of the weld joints of end lifting lug to Longitudinal Diaphragm (LD) of OBG segment 13BE at PP121.5. During welding there was no proper preheat and run of tab at the end of weld joint identified as SEG 3009K-172. Welder is identified as 044774. This QA inspector informed ZPMC CWI Mr. Geng Wei regarding this issue. Mr. Geng Wei informed this QA that this issue would be corrected in a manner compliant with the contract documents. Attached photographs provide additional information.

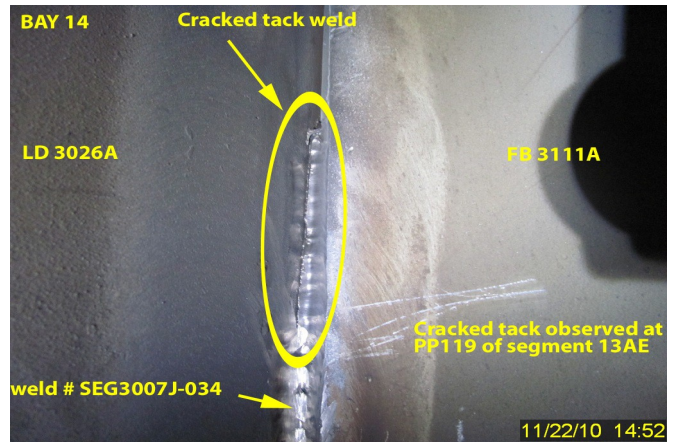
During random in process inspection of Orthotropic Box Girder (OBG) member identified as segment 13AE this QA observed cracked tack welds on weld joint identified as SEG3007J-034 joining floor beam (FB3111A) to longitudinal Diaphragm (LD3026A) at panel point no. PP119. This QA marked the cracked tacks and informed ZPMC Quality Control (QC) identified as Mr. Zhong Yong Gang of this issue. Mr. Zhong Yong Gang informed this QA that the cracked tacks would be corrected in a manner compliant with the contract documents. Attached photographs provide additional information.
